Synkote Paints 14:40 4/3/89

Set A

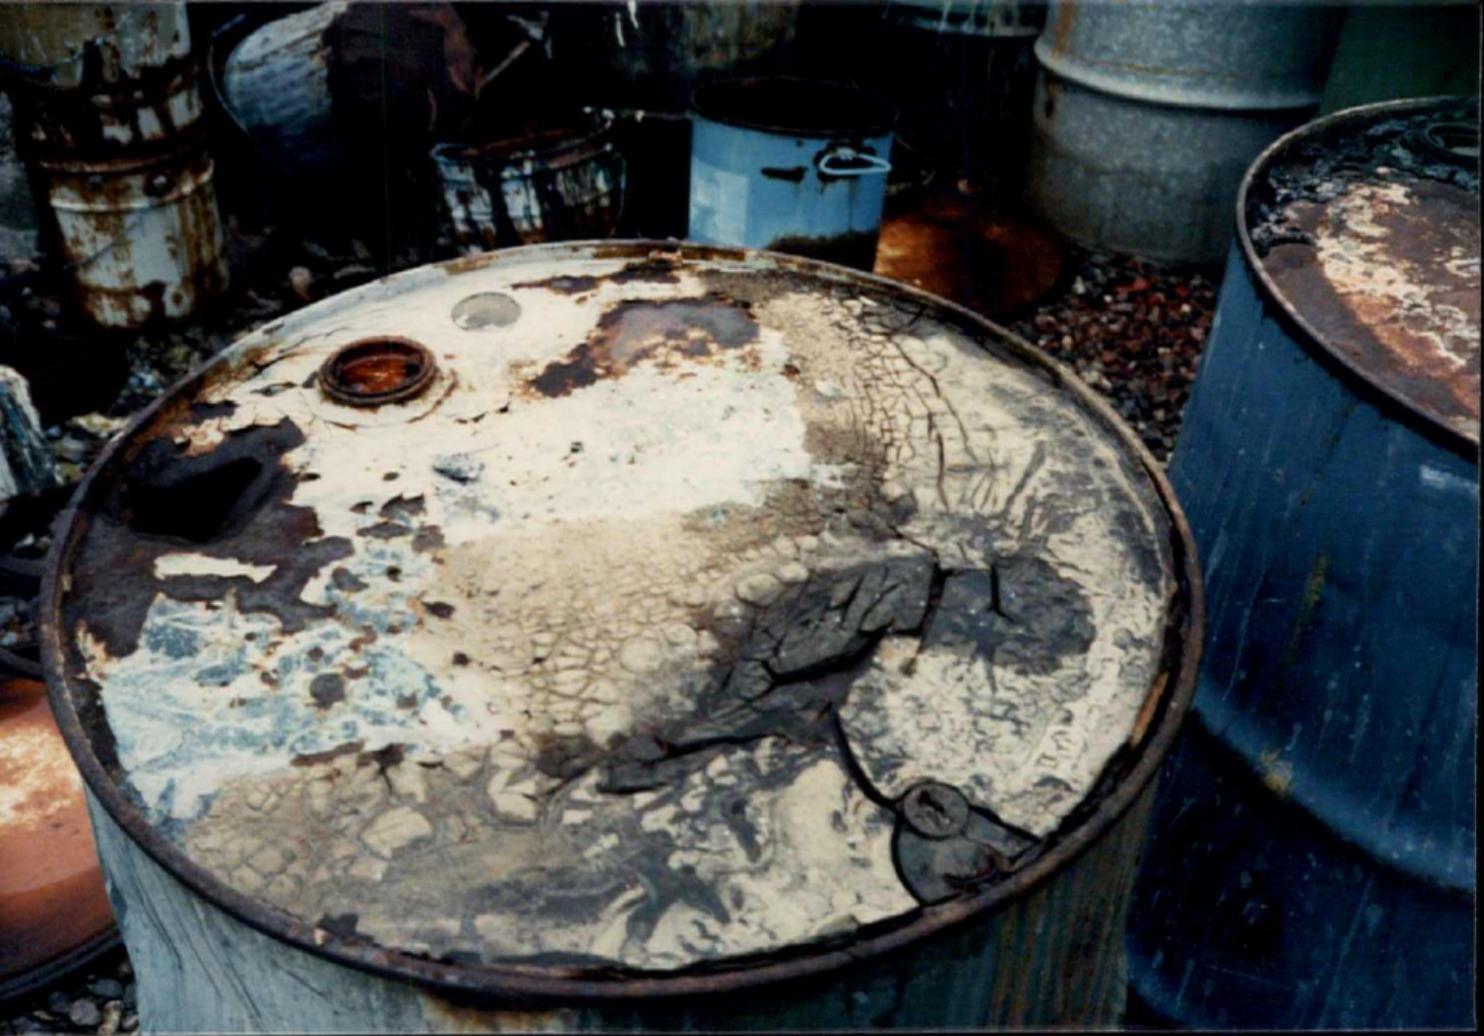
View of drum with corroded
top. Elevated OVA readings were
obtained inside the hole on the left.

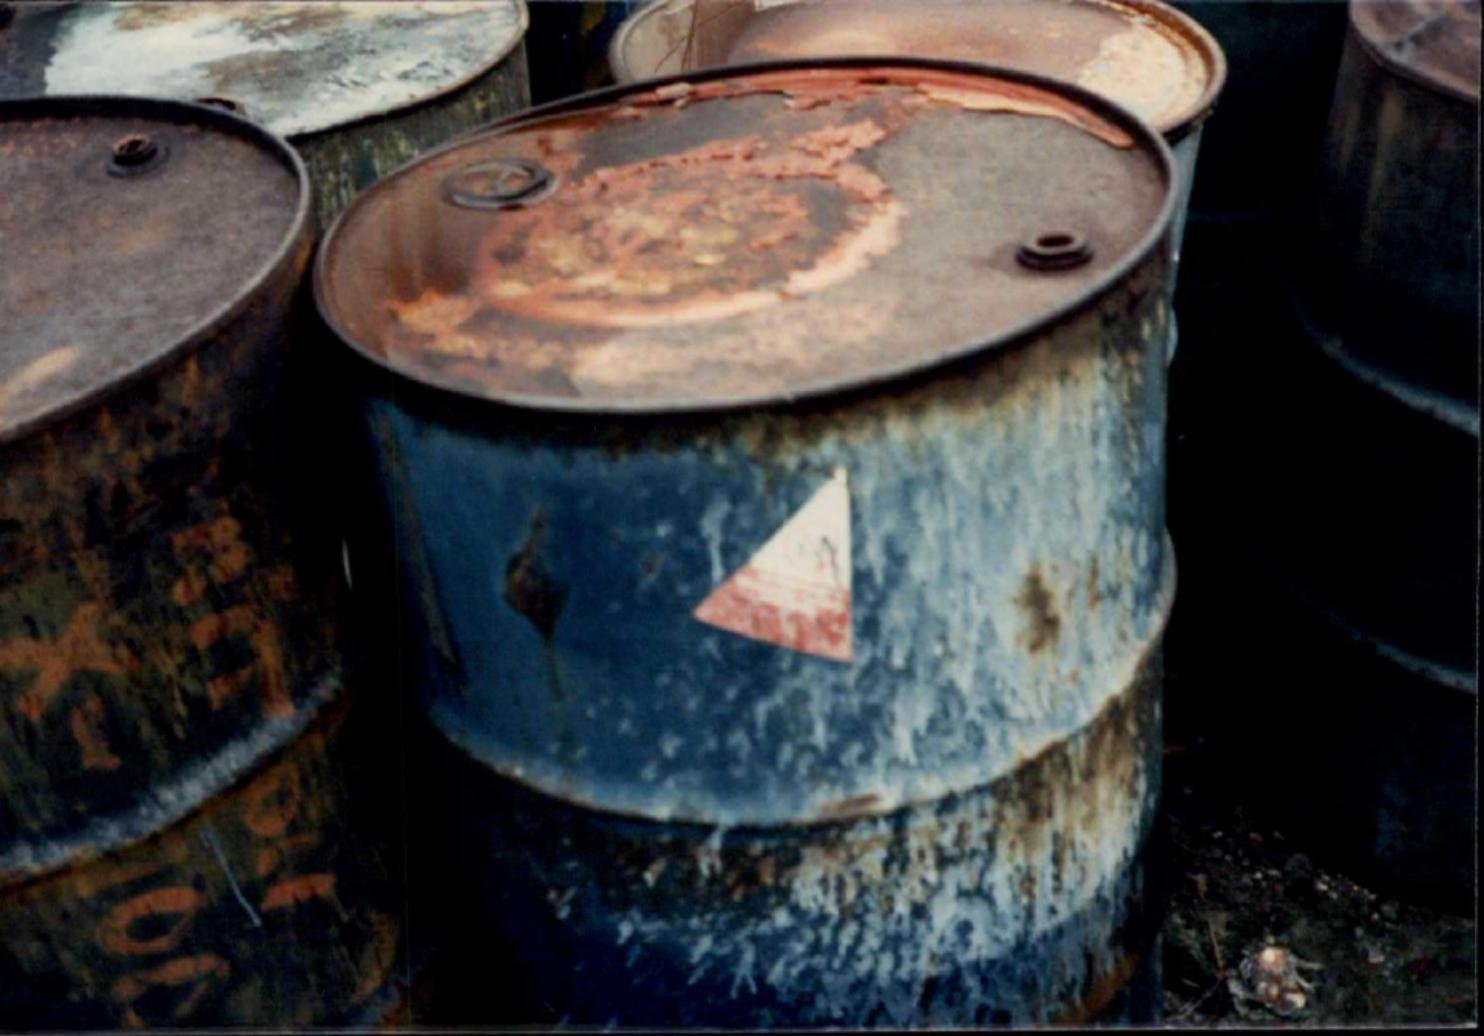
Photo of warning label on one of
the drums indicating a explosion
threat when empty.

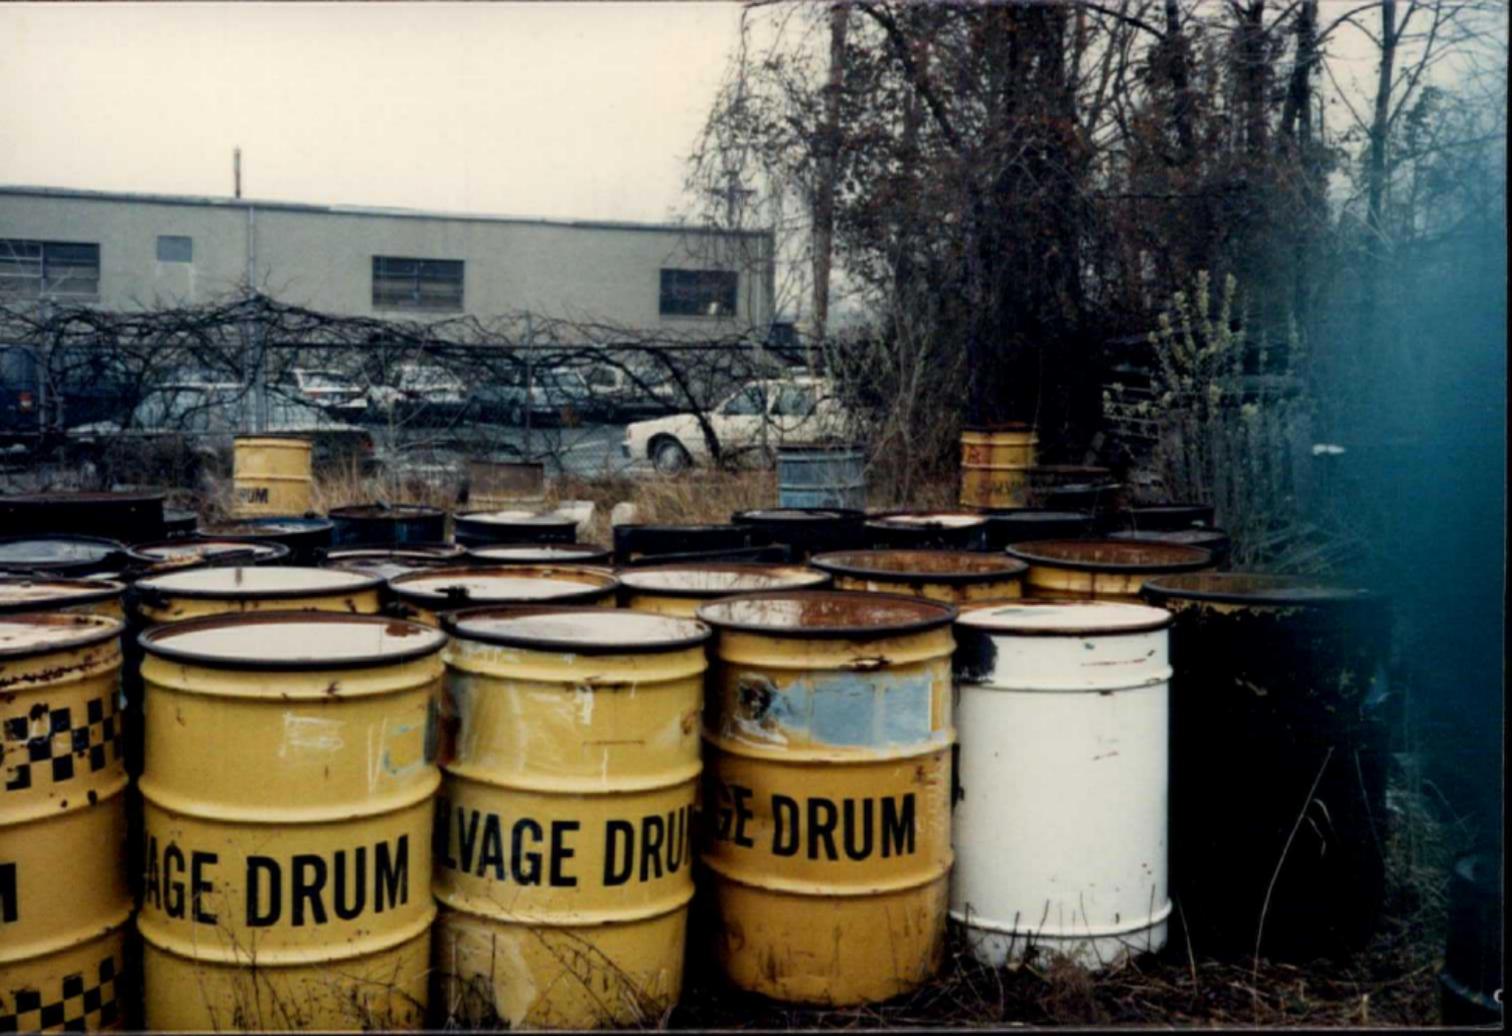
View of rusting overpack drums
located next to a parking lot at
a neighboring workplace.

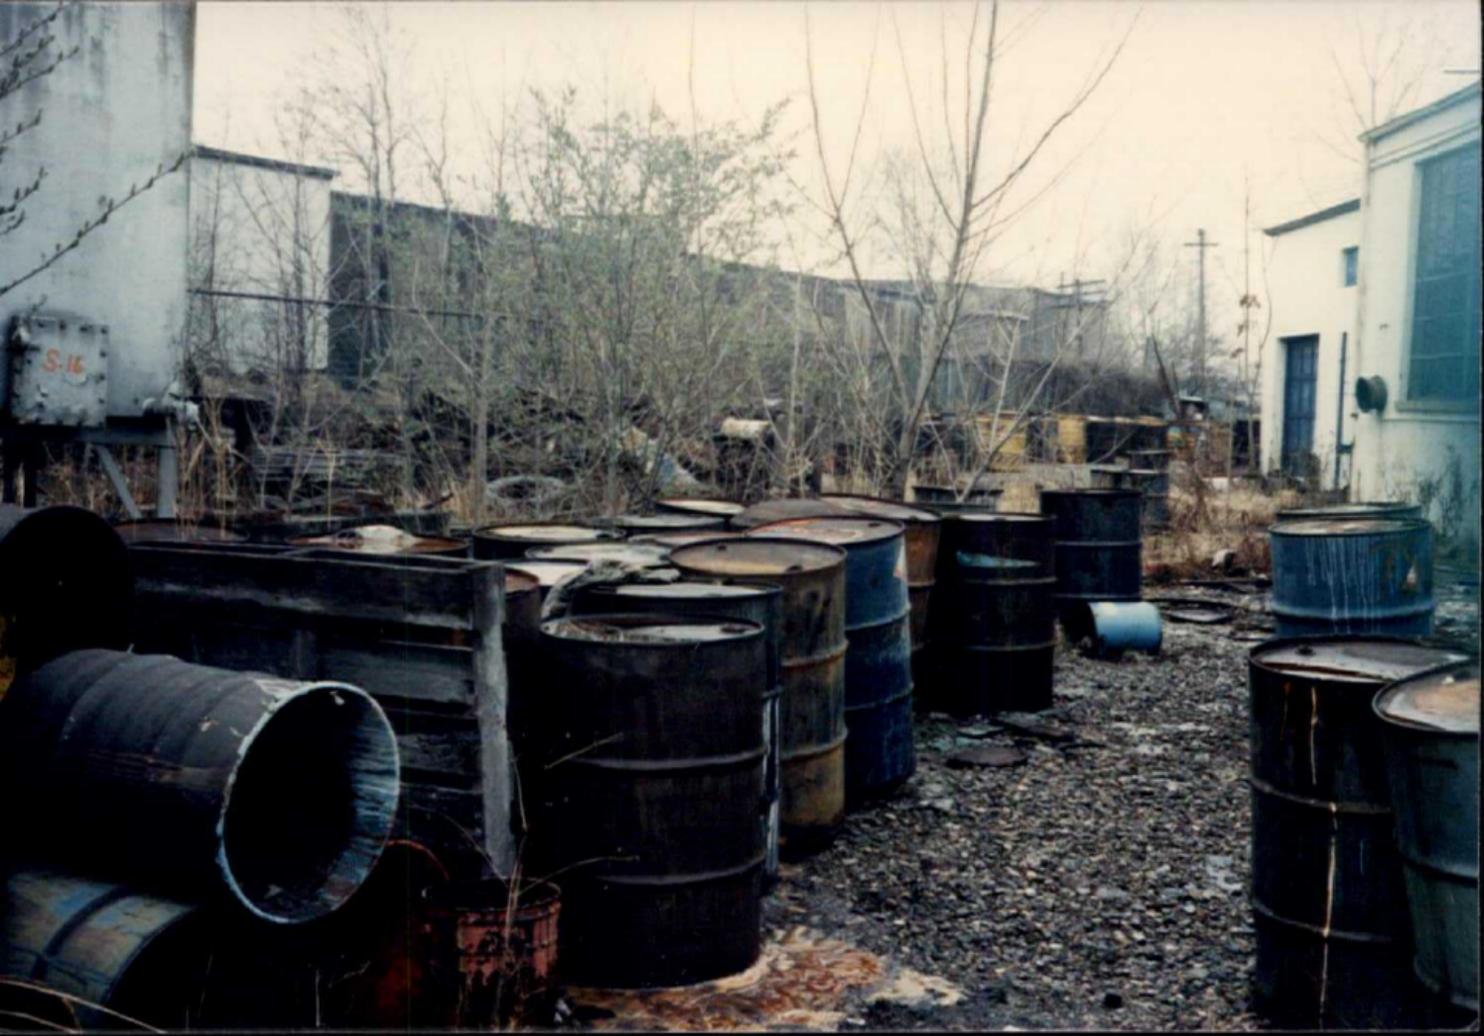
View of rear of site looking east, site is enclosed with a fence. Note soil contamination

from leaking drum in center of photo.
